MISSION OPERATIONS DIRECTORATE

Operations Support Officer In Space Inspection Experience and Needs

DX42/Daniel Perri (USA)
7/15/2014

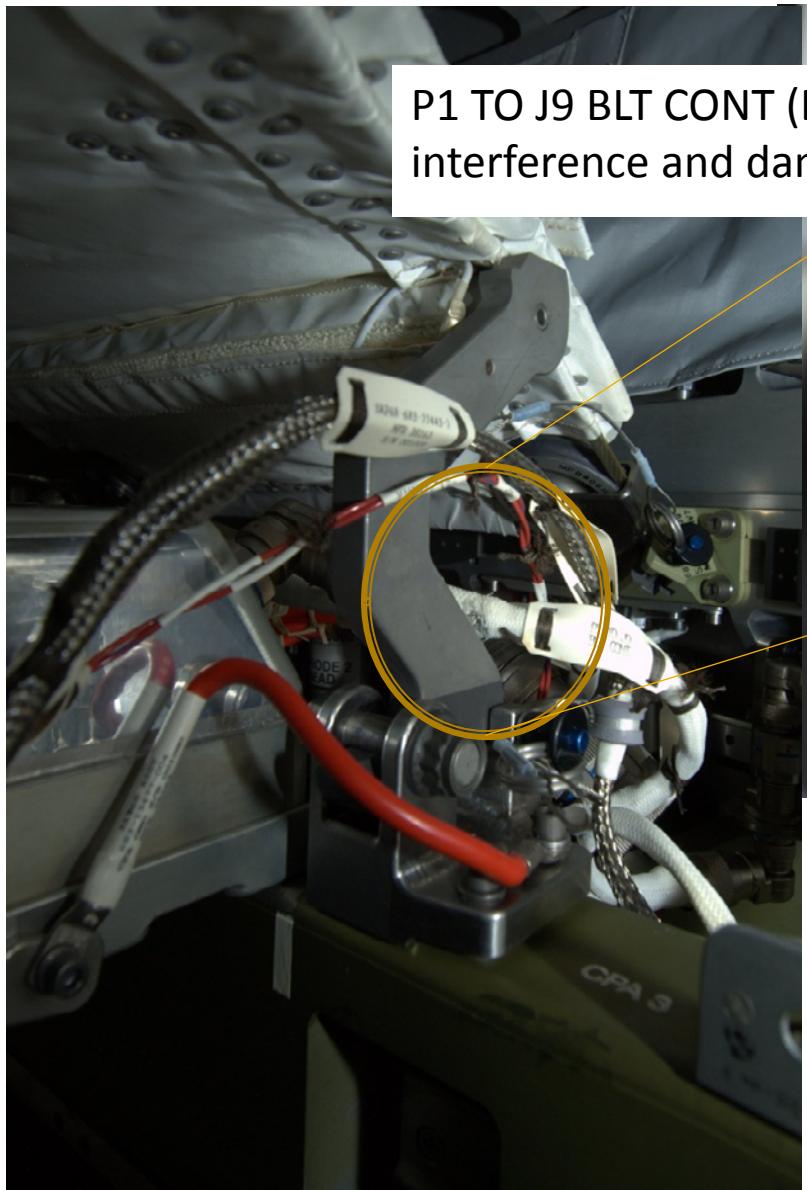
- Inspection Imagery finding otherwise unreported damage or contamination

P1 TO J9 BLT CONT (Bolt 3-4)
interference and damage

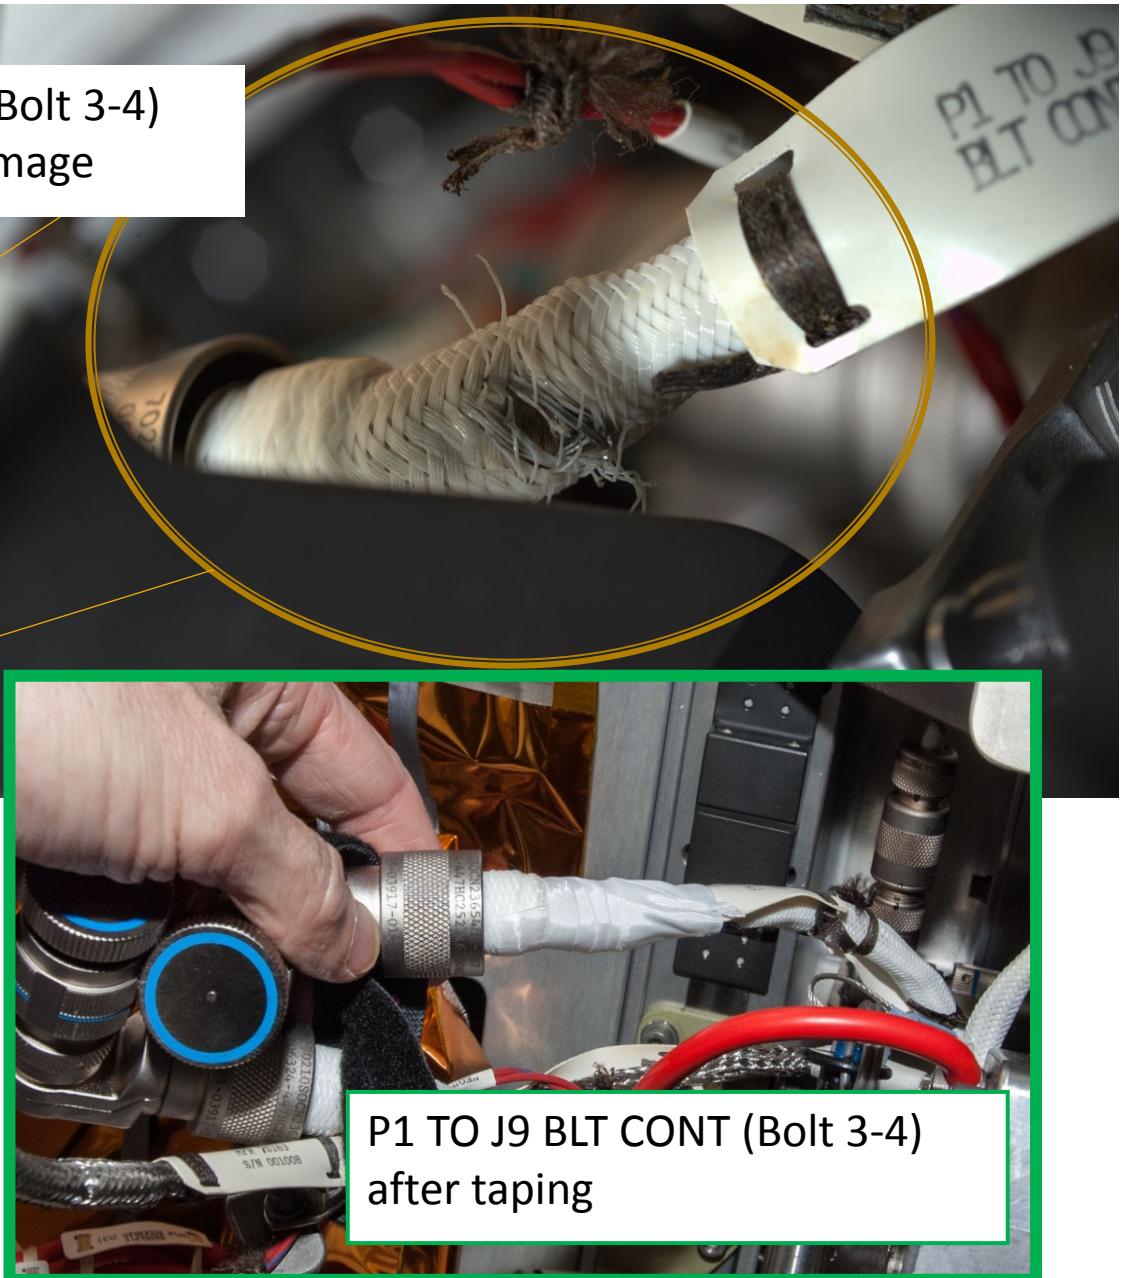
P1 TO J9 BLT CONT (Bolt 3-4)
after taping

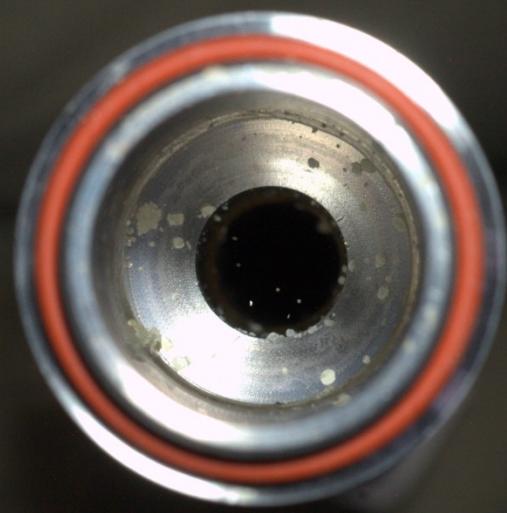
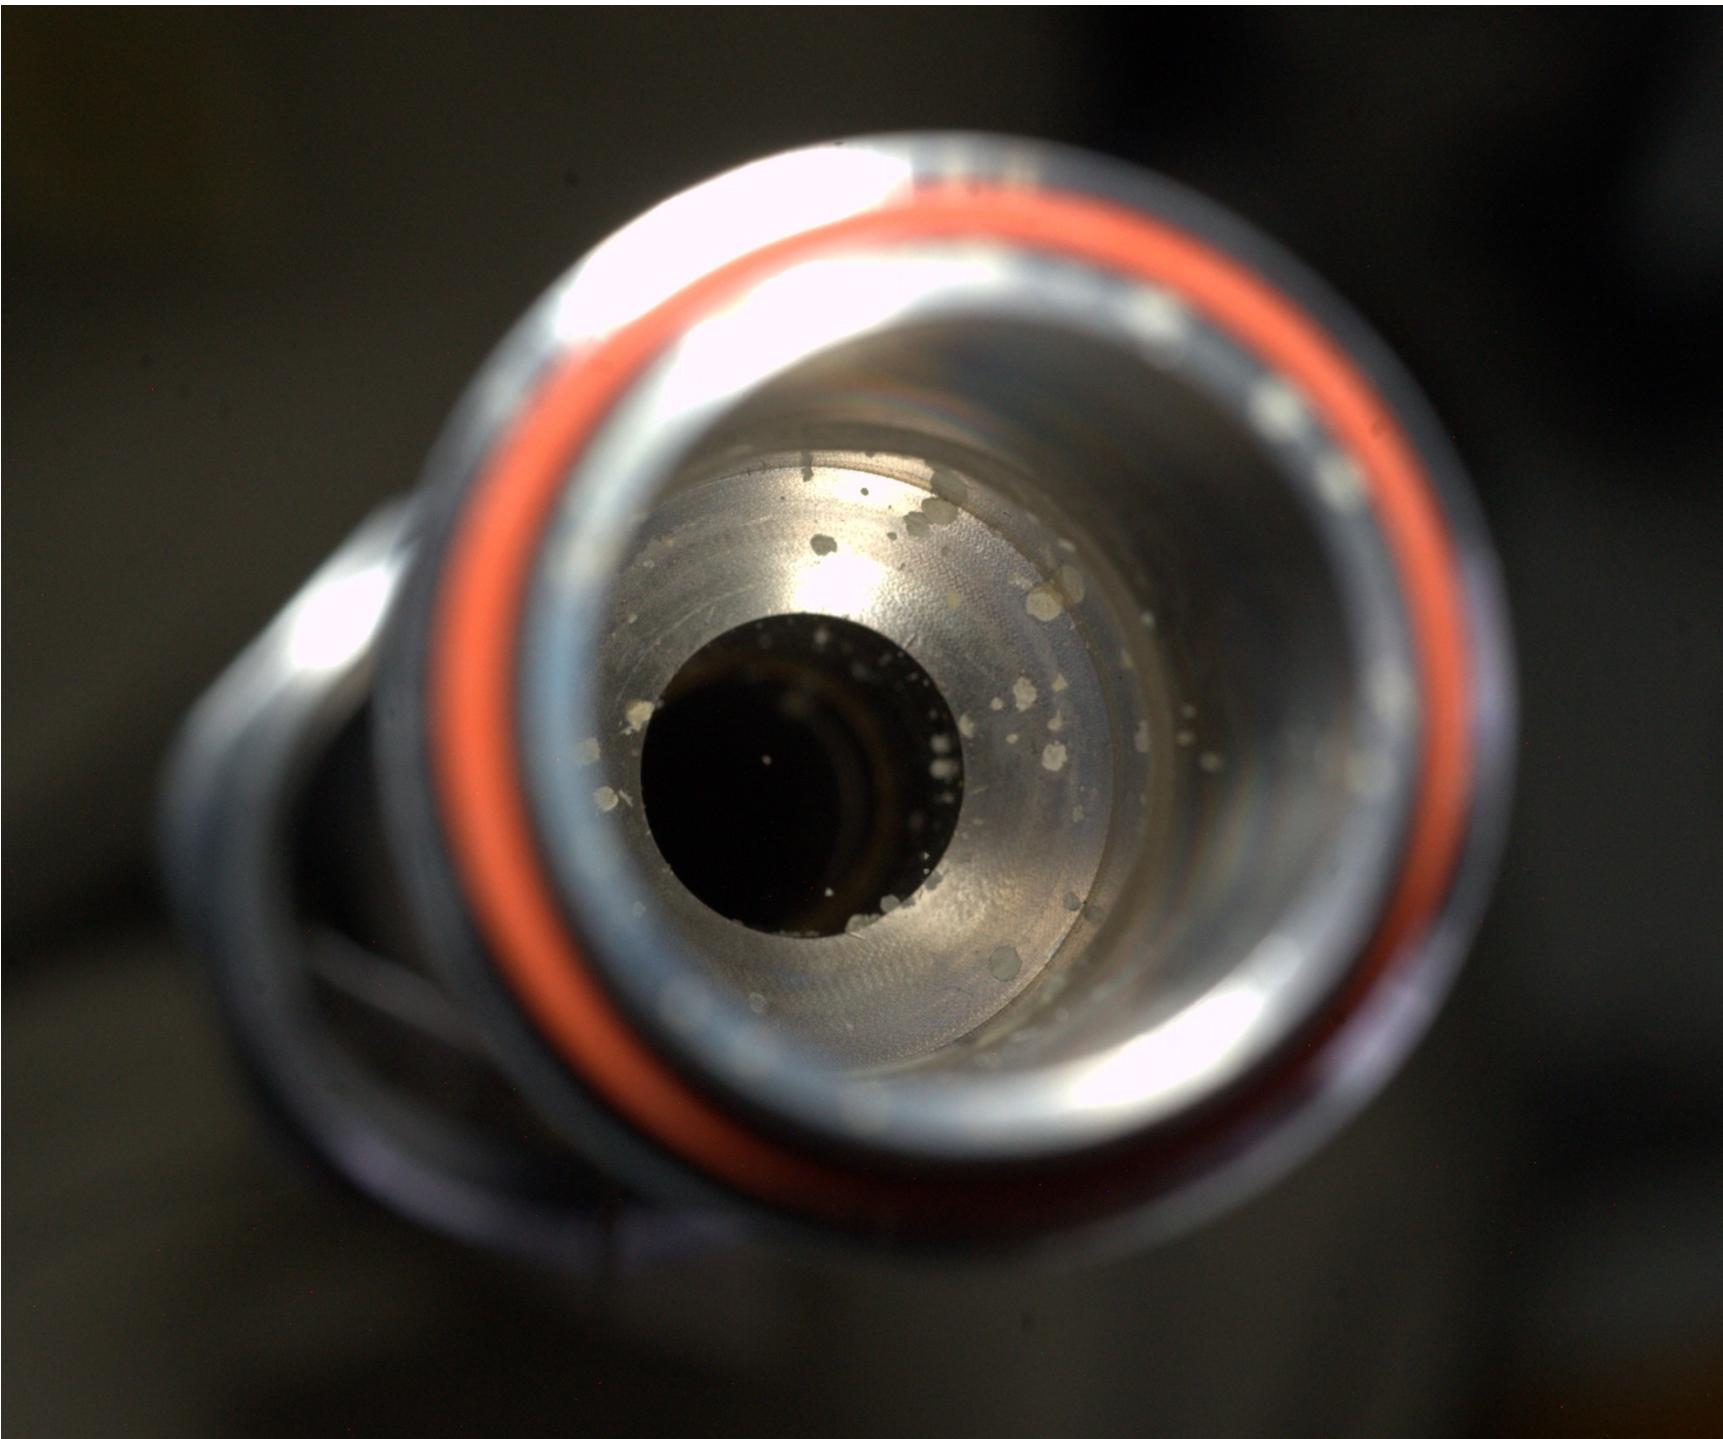
- White debris reported by crew during an inspection before installing an ITCS line during maintenance.

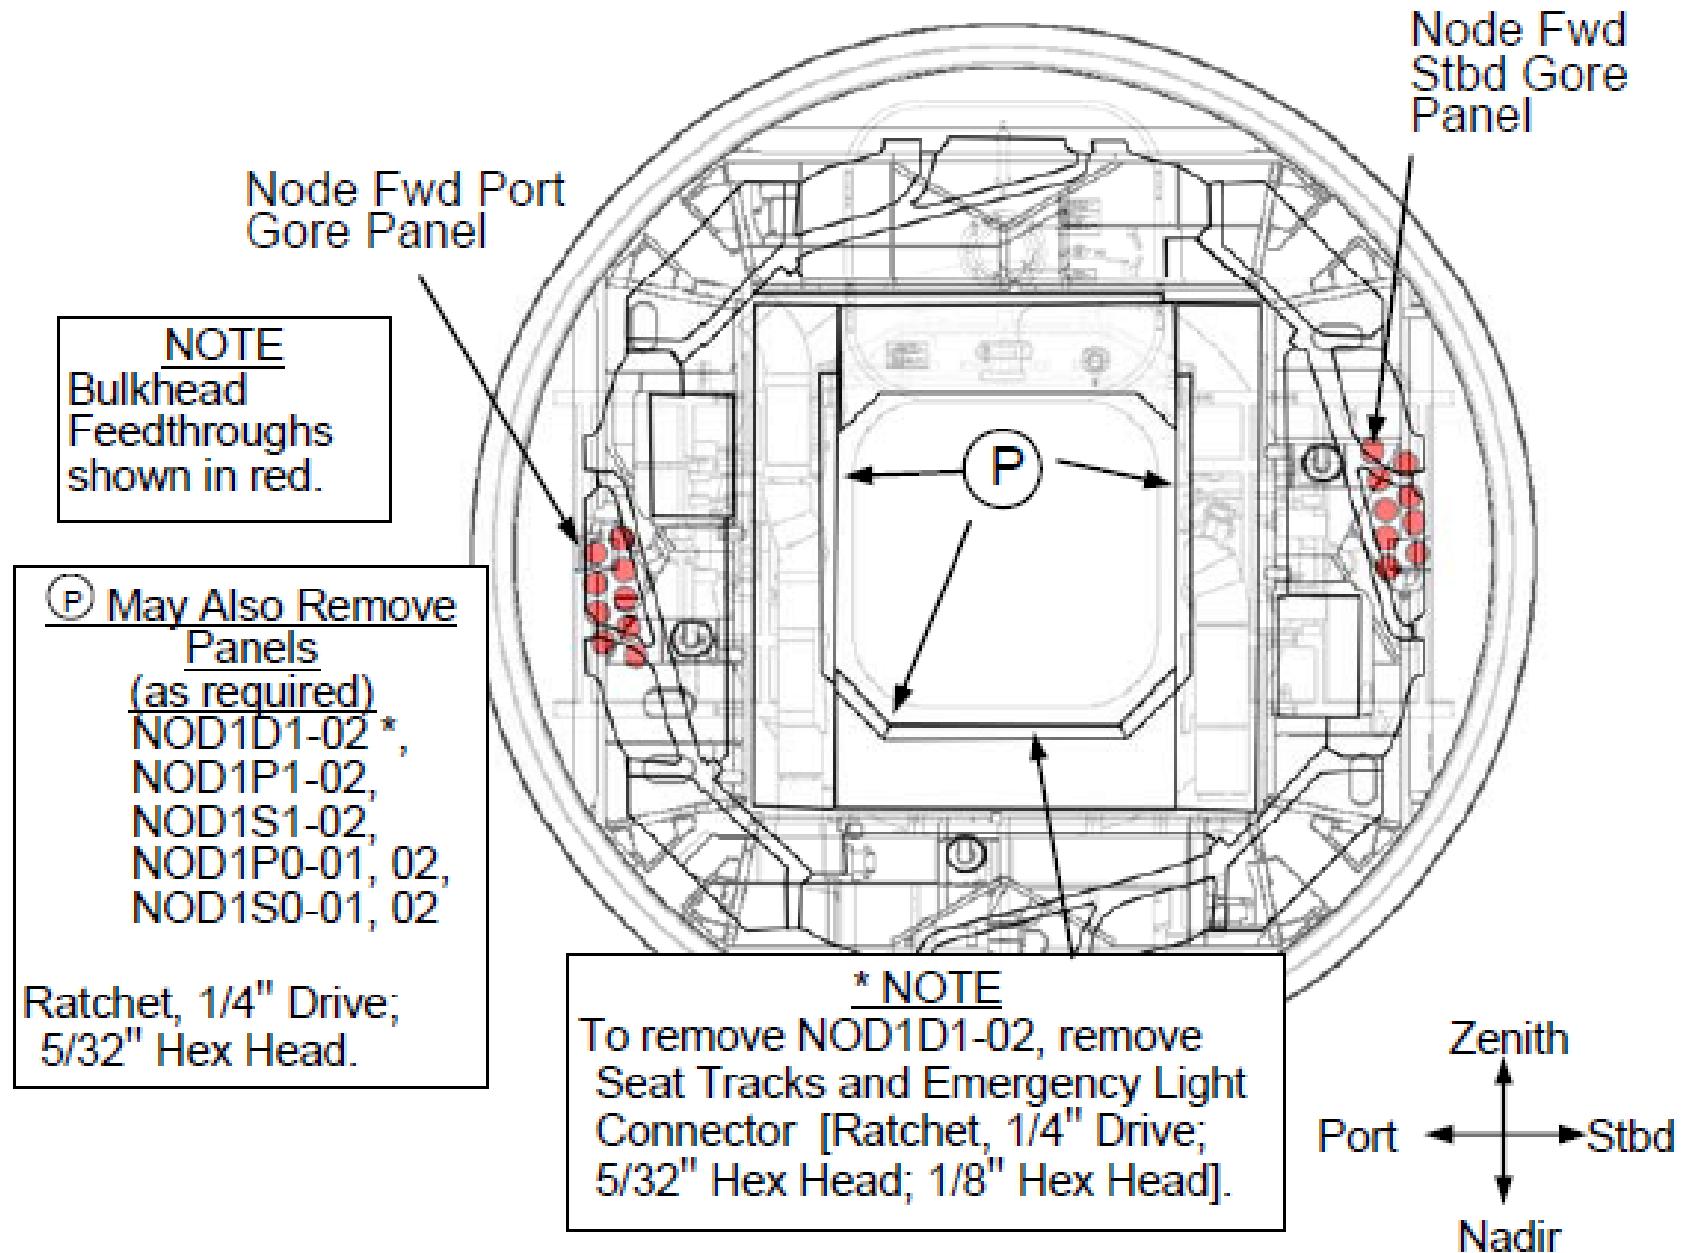
Figure 2.- Node 1 Fwd Endcone.

- Use of schematics and other engineering data in procedures.
- Techniques to provide scale to imagery of MMOD damage.
